Archeological Research Series Architectural Studies Number 4

Prelude to Tapestries in Stone: Understanding Cliff Palace Architecture

Larry V. Nordby

2001

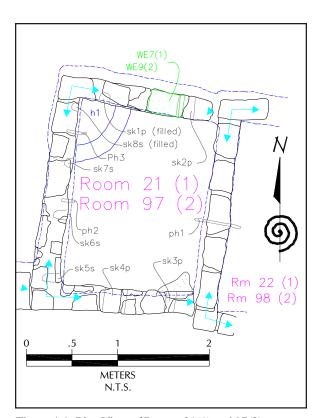
Figure 4.4. Plan View of Rooms 21(1) and 97(2).

Room 21(1) is in stable condition, and has no active deteriorating agents. Even the dado is stable.

Room 97(2) is in entirely stable condition.

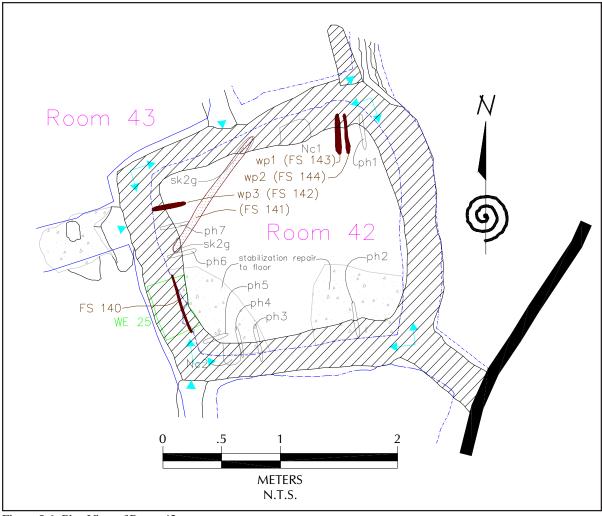
Figure 5.6. Plan View of Room 42.

Room 42 is in pristine condition and totally stable. The only alteration to the interior of the unit is along the north wall and northern portion of the east wall where both

areas have lost the plaster along the basal 5 to 10 cm. This damage results from higher soil levels on the exterior of each affected wall. Any moisture from areas around the room tends to move into the room and as it evaporates the plaster exfoliates.

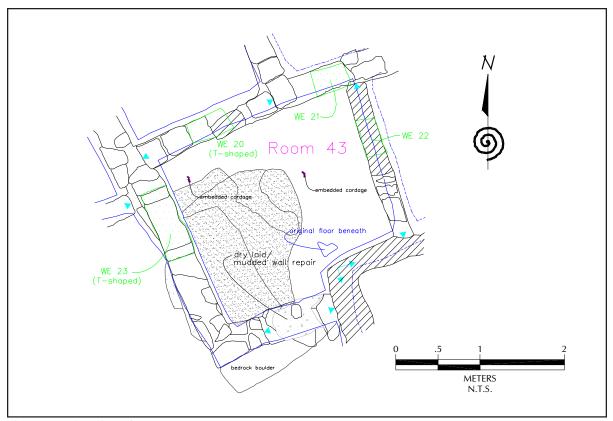
Figure 5.7. Plan View of Room 43.

Room 43 has no wall pegs or peg holes (Room 45 does have the pegs). The mutilation to which Fewkes refers could be in Room 43, since a section of the southern wall has fallen or been pushed out, and a sector of drylaid mudded masonry installed. The mudding is limited

to the interior facade. This may have taken place during the modern era, or it may have been a prehistoric repair.

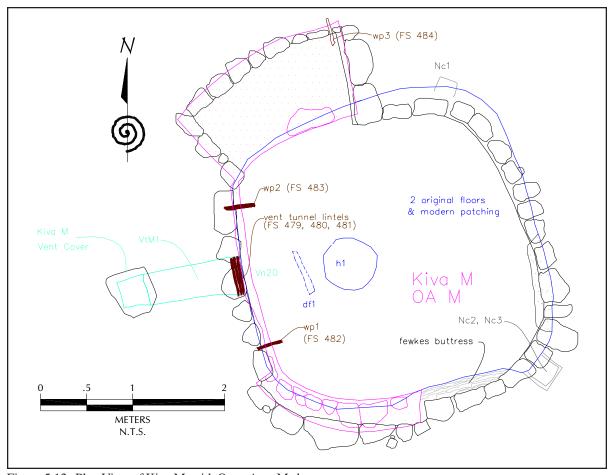
Figure 5.12. Plan View of Kiva M, with Open Area M above.

work. No other stabilization work is documented, although patches of stabilization work done in portland cement are now present. No documentation on when these were added or who did the work has yet come to light.

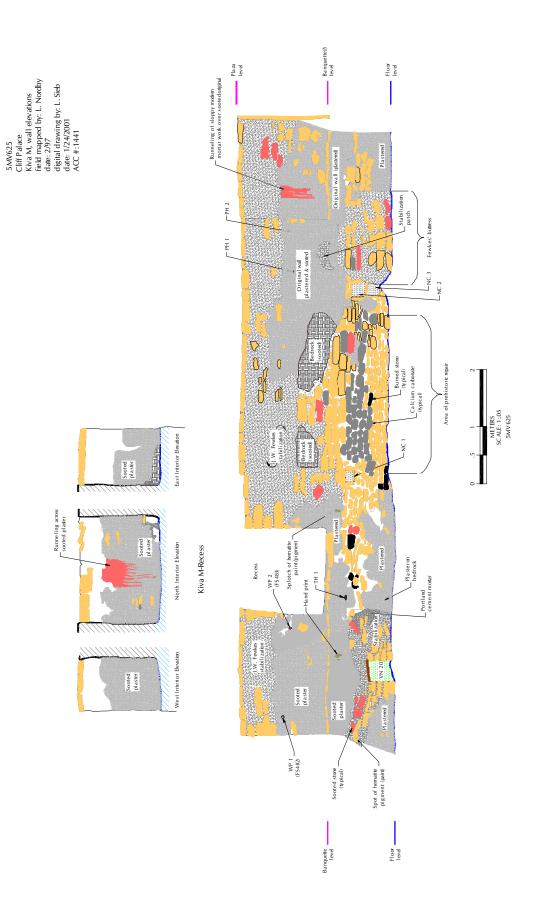
Figure 5.13. Cliff Palace - Kiva M, Interior Elevation.

There is loose fill in Kiva M either from breakdown of the veneer joints and spillage of unconsolidated fill from behind the veneer into the kiva or from windblown sediment. The concentration of this debris at the base of the ventilator tunnel and Niches 3 and 4 suggests that most of it is cultural sediment from behind the veneer,

not aeolian sediment. This may have been accelerated by rodents.
